(Bulletin for Statehouse, Capitol Mall Employees May 20, 2002)

Department of Administration
Construction Update No. 38

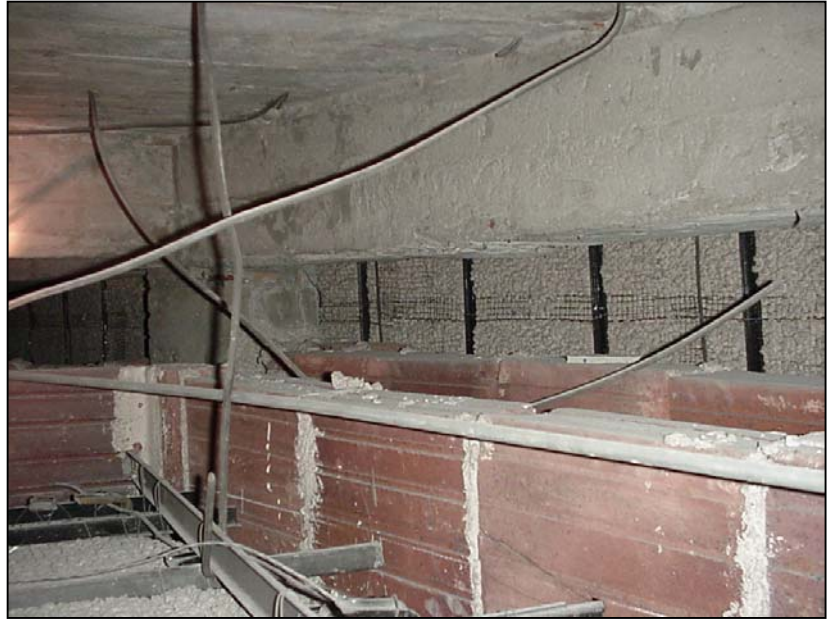
Danielle Weaver, CSHQA, sent us the picture (to the right) of the space between the original plaster ceiling in the State Capitol and the concrete structure above.

Danielle reports that in general everything was as expected above the plaster ceilings. The only big surprise was that above the House of Representatives chamber entry, there are two plaster ceilings built on top of each other, with about an 8” gap between them. CSHQA’s theory is that during the first phase of the Capitol construction, they built the highest plaster ceiling; then they built the lower one during the second phase to provide a continuous ceiling into the wing addition. Danielle tells us that most of the thick walls in the Capitol are constructed from large clay tiles, and you can see one of these walls in this photo. There is also a concrete beam above and the backside of the House of Representative’s east wall is beyond.

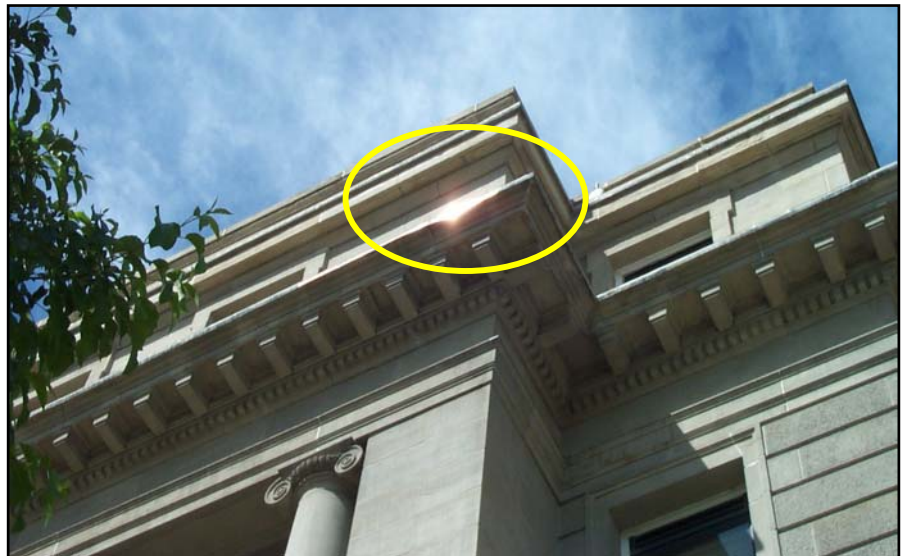
Jan Frew, Division of Public Works Design & Construction Manager, answered Eric as follows: “The material you are referring to is called flashing. Its purpose is to divert water off of the horizontal stone surface. It is made of copper. Copper is used in this type of application because of its corrosion resistance and longevity. This is borne out by the current condition of the flashing. There were very few areas that needed to be replaced. The bright sections you see are new materials replacing areas that had cracked or failed.

As the copper ages it will take on a patina or weathered look that is dark grey, nearly black. This is a normal and expected process. To clean or “polish” the existing copper would actually damage the copper sheet due to the amount of abrasion needed to scrape off the outer aged layer. Within a few years the new sections will blend in with the old. An interesting side note is that the copper patina in coastal or humid areas is green in color, not black. Those lovely photos of old Italian cathedrals with green roofs is an example of this.” *The photo above shows some new copper flashing on the south side of the Capitol; the part with patina is not reflecting the sunlight like the new does.*
